CR 84.031

EVALUATIONS OF HRI FACILITIES AT NS MAYPORT AND NAS JACKSONVILLE,
FLORIDA—LESSONS LEARNED REPORT

July 1984

An Investigation Conducted by:
SYSTECH CORPORATION
245 North Valley Road
Xenia, OH 45385

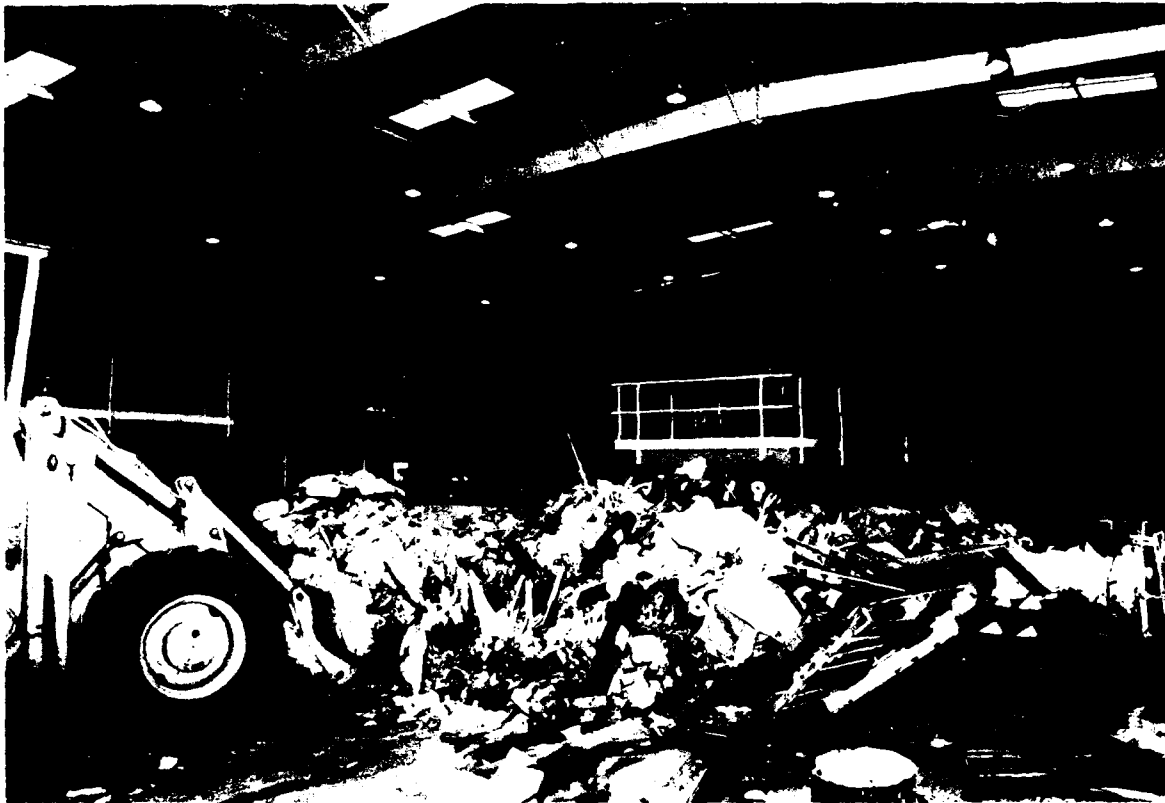
Figure 7. View of as-received waste at NAS Jacksonville prior to hand sorting to remove large bulky items and nonprocessibles.
